Edge-of-Field Technical Report

March 31, 2024

1.0 Introduction

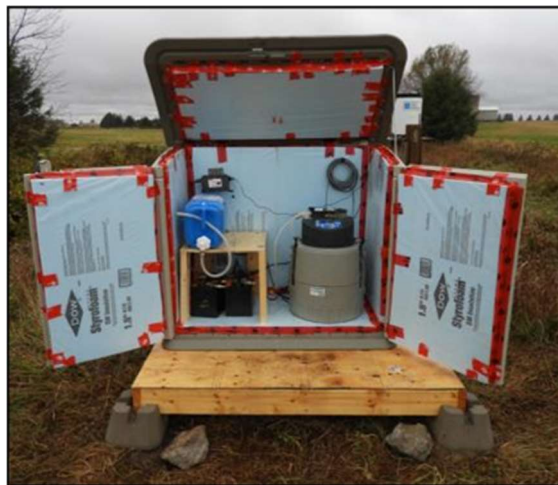
Figure 3. The inside of a water monitoring station established by UTRCA

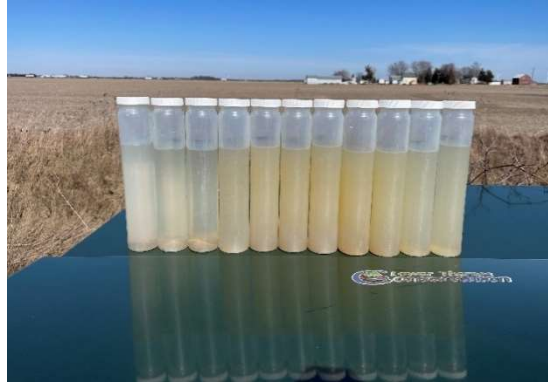
Figure 4. Visual assessment of variations in water quality following a sampling event, demonstrating baseline [Left], rising flow [Middle Left], peak flow [Middle], and descending limb of flow [Right].

Monitoring includes surface runoff flow and water quality, and where possible, subsurface (tile drainage) flow and water quality at most sites. This monitoring is visualized in the conceptual diagram shown in Figure 2. Overland flow patterns were assessed at site establishment to ensure all flow leaving a sub-watershed within the field area was directed through flumes or water control basins. Monitoring the rate of flow and the depth of water allowed for the calculation of discharge at any given time. Similarly, sensors in the tile drain captured subsurface flow rates. ISCO water samplers were used to collect samples for water quality analysis at regular intervals when triggered by the flow sensors Figure 4. Visual assessment of variations in water quality following a sampling event, demonstrating baseline [Left], rising flow [Middle Left], peak flow [Middle], and descending limb of flow [Right]. Figure 4. Figure 3 shows the inside of one of the water quality monitoring stations with this equipment in place. Figure 4 shows the visual variation in water quality following a sampling event at Merlin B.

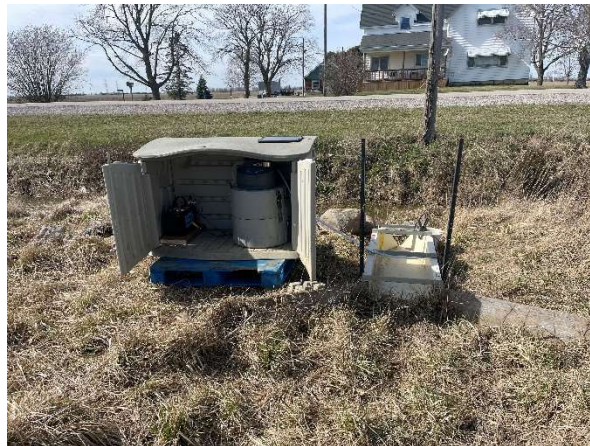
Figure 5. Merlin A's flume newly installed permanent enclosure with a solar panel.

Recent improvements have been made to the site including installing a permanent structure to house an ISCO 6712 (Figure 5), as well as improved telemetry which will allow us to remotely monitor flow and to select sample bottles before getting to the field.

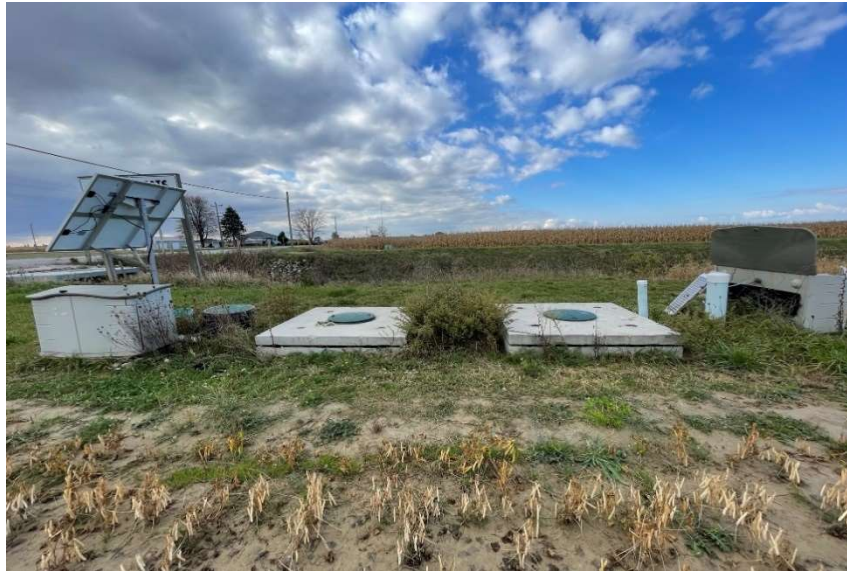
Figure 6. Fairview site containing an inflow permanent ISCO enclosure with solar panel [Right], first tank [Right Middle], second tank [Left Middle], and outflow permanent ISCO enclosure with solar panel [Left].

The Fairview site is located approximately 30 kilometers east of the Merlin A and B sites or 15 kilometers east of Chatham. The field is 100 acres, has high soil phosphorus levels, poorly drained soils, and drains into the Thames River. The Fairview site was previously used to test phosphorus absorbent materials and contains two tanks, and an inflow and outflow ISCOs (Figure 6).

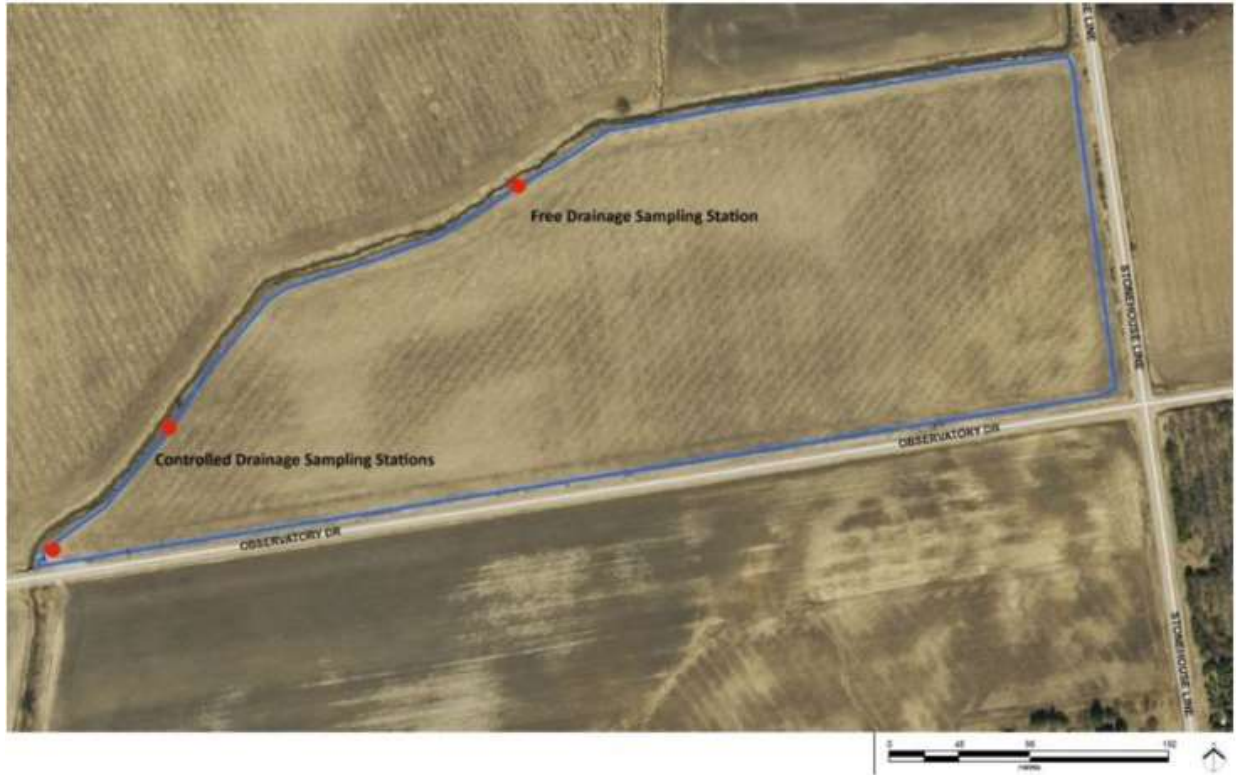
Figure 8. Upper Medway EOF Site.

Within the Upper Medway Creek subwatershed, data will be captured from a unique EOF site that has been monitored since 2015 by Agriculture Agri-Food Canada (AAFC). At the Controlled Drainage Site, tile runoff is sampled from two controlled drainage plots and one free drainage plot (Figure 8). This site is currently being monitored to show the impact of controlled drainage on water quality. There is an opportunity to demonstrate and compare the effects of stacking of BMPs in the future, such as the impact of cover crops and controlled drainage. This site is highly valuable to the Upper Medway project, given the long history of background data that has been collected here.

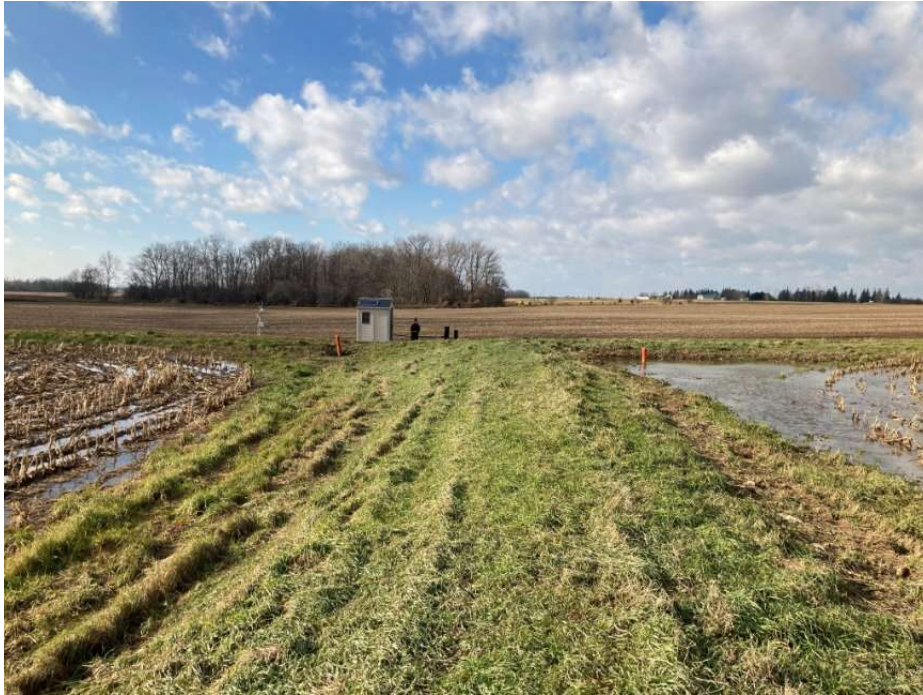
Figure 9. Photo of T-shaped berm separating the two monitored catchments at the North Kettle EOF.

In the North Kettle Creek subwatershed, an EOF station was constructed at a T-shaped berm that separates two distinct catchments in the field (Figure 10). Each side of the berm also has a separate surface inlet and tile outlet, allowing for different treatments to occur on either side. The North catchment serves as the experimental side, with a cover crop planted each fall, while the South catchment provides the control where no cover crop is planted (Figure 11).

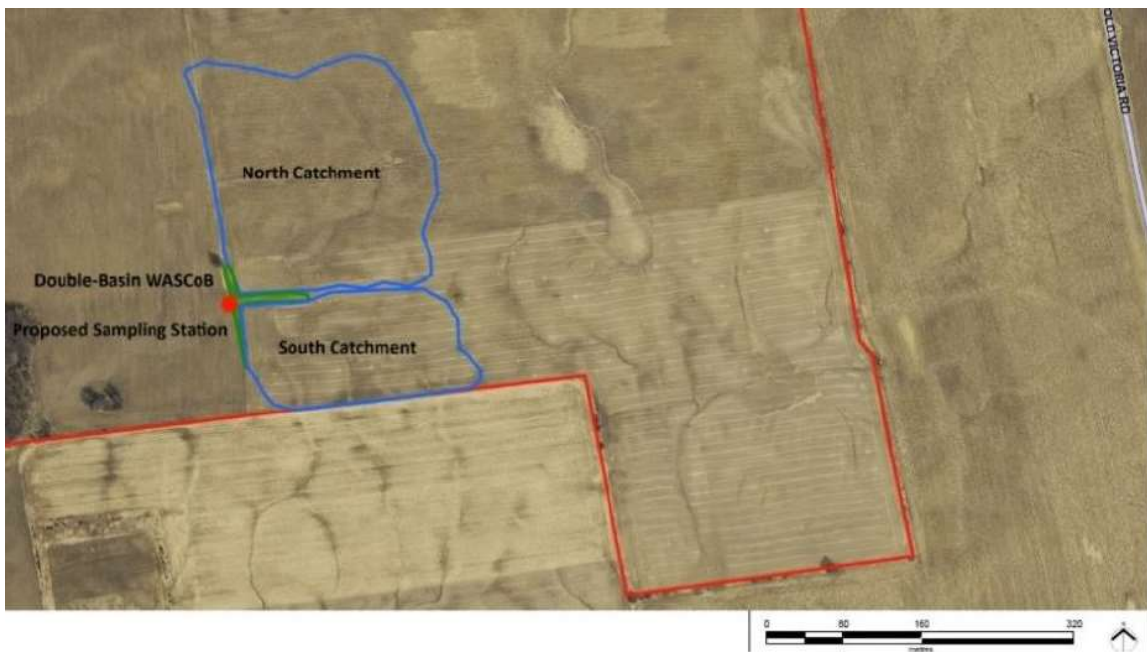
Figure 10. Site map showing the layout at the North Kettle EOF.

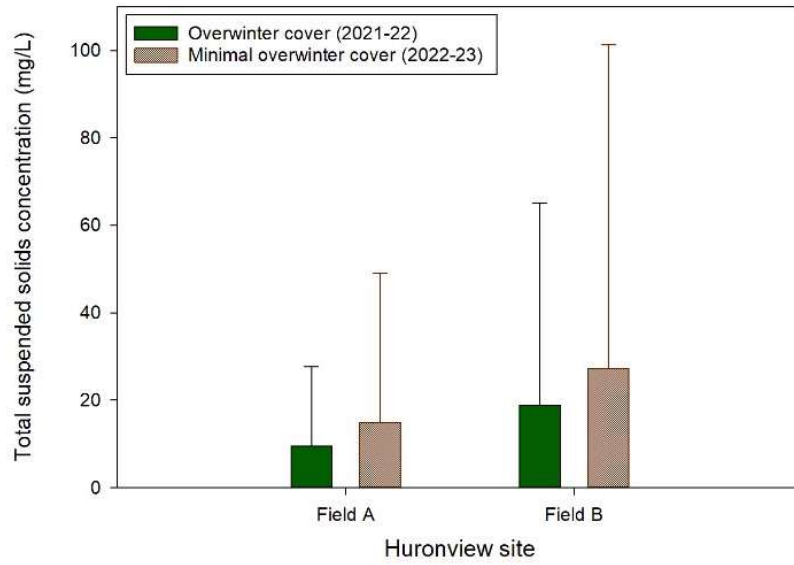
Figure 11. Total suspended solid concentrations at Huronview Fields A and B.

The results from EOF monitoring have shown that increasing over winter cover, both living or dead, can reduce the occurrence of runoff and nutrient concentrations, leading to lower losses overall. Figures 12-14 show that at Huronview concentrations of suspended sediment, phosphorus and nitrate were lower when there were higher levels of overwinter cover. However, there has been variability in water quality benefits and crop performance at the sites, which warrants further investigation. The amount of surface residue matters in-terms of the water quality impact, as well as for crop performance. In years with less residue cover due to poor cover crop establishment, the benefits were not significant from a water quality perspective, as was observed at the North Kettle EOF site (Figure 14 and Figure 15). From the agronomic perspective, there have also been circumstances where the management of cover crop residue led to notable differences in crop performance. At Huronview, high cover crop residue led to lower nutrient concentrations in runoff through the winter. However, the high residue led to a poor crop of no-till soybeans the following growing season relative to where the same residue had been sprayed and strip-tilled. This highlights that there is more to learn to optimize overwinter cover to achieve environmental and production benefits. The plan for this next phase of ONFARM is to continue to evaluate the effectiveness of overwinter cover. An emphasis will be put on documenting conditions that may lead to increased water quality benefits and crop performance.

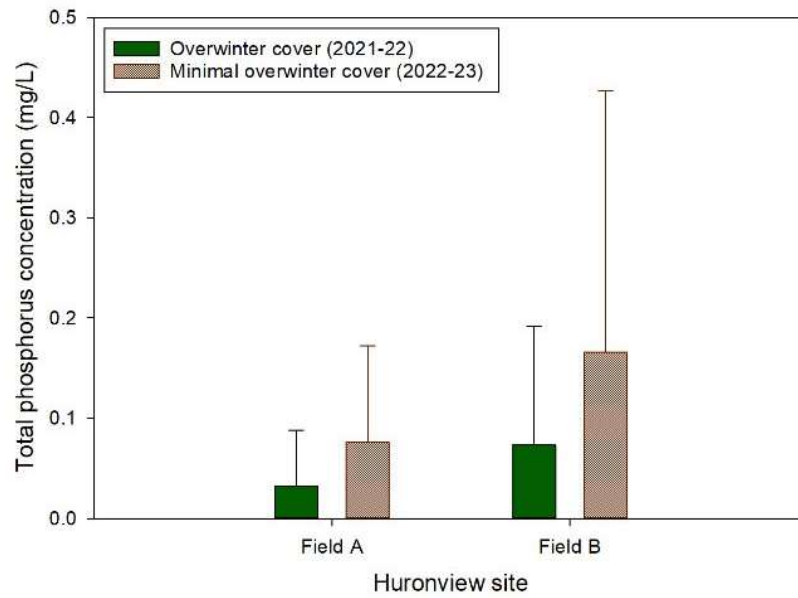
Figure 12. Total phosphorus concentrations at Huronview Fields A and B.

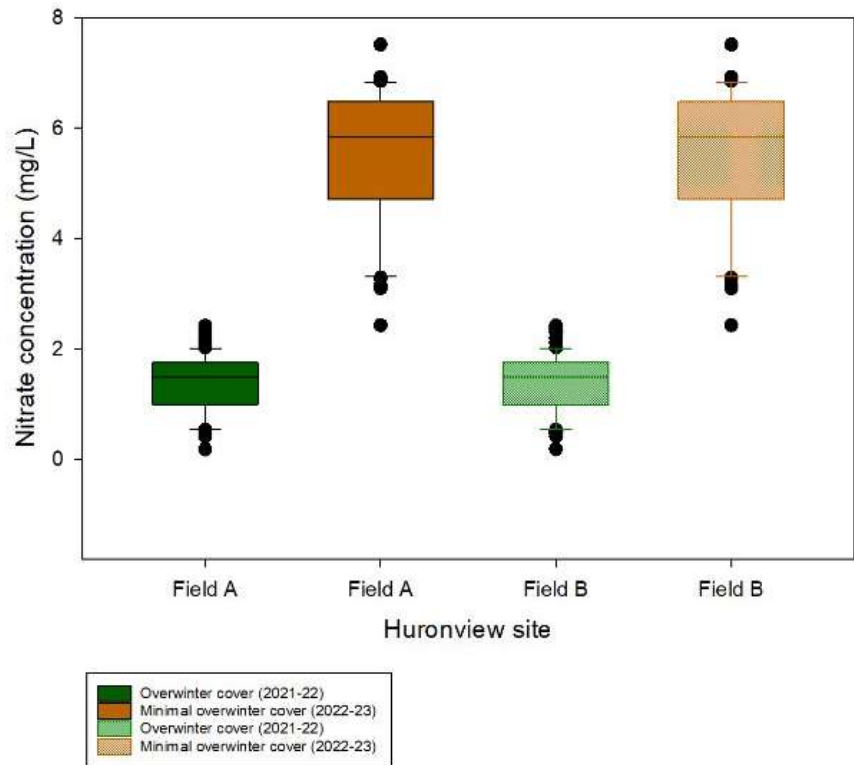
Figure 13. Nitrate concentrations at Huronview Fields A and B.

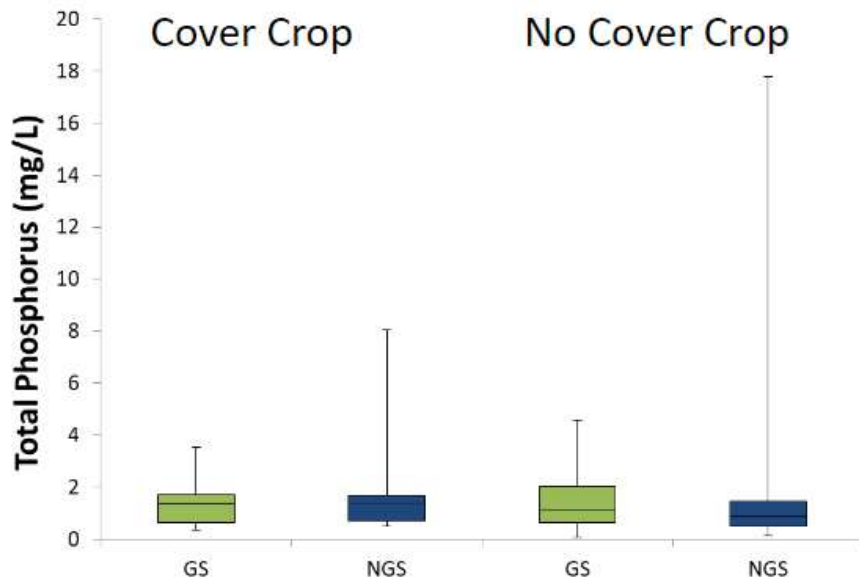
Figure 14. Total phosphorus concentrations at the North Kettle EoF Site

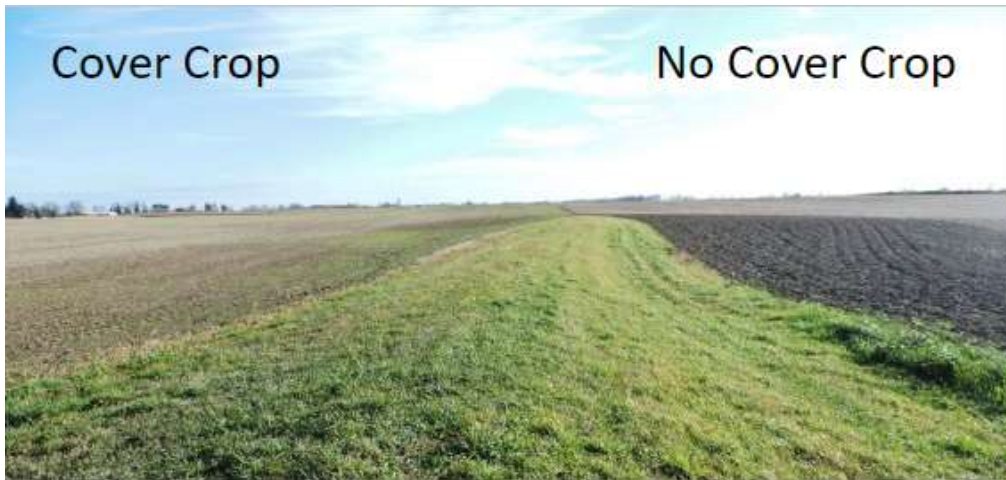
Figure 15. Visual of cover crop establishment relative to no cover crop plot at North Kettle EoF.

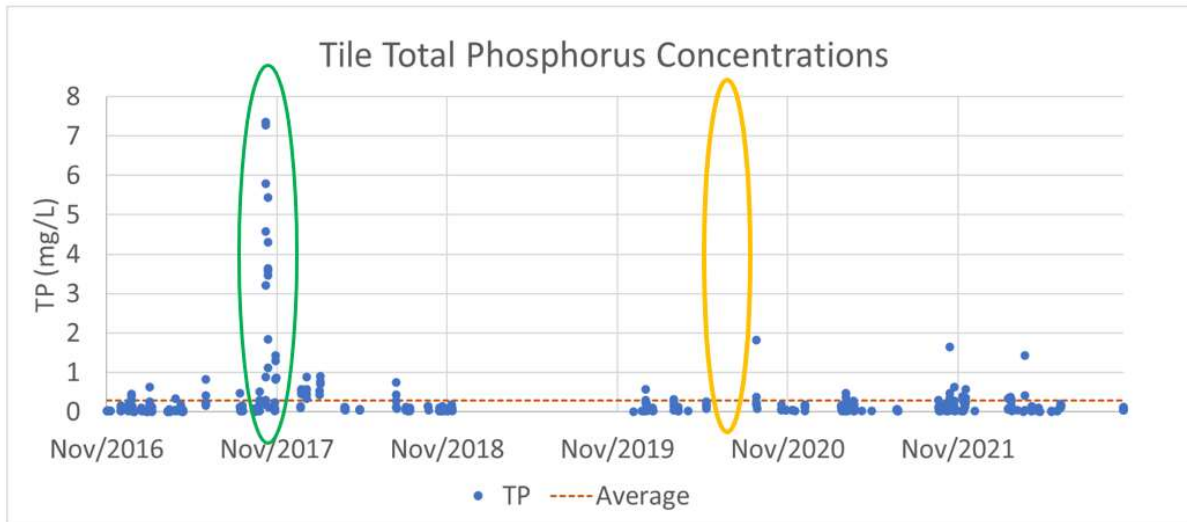
Figure 16. Total phosphorus concentrations in tile runoff at the Garvey-Glenn EoF. The green oval indicates a fall manure application, and the yellow oval indicates a summer application.

There are no paired trials within ONFARM that are set up to evaluate water quality impacts of nutrient applications. Still, there have been notable high loss events that were directly related to nutrient applications at the sites. In previous years there have been significant nutrient losses when fertilizer or manure applications were followed by heavy rains or melts. Elevated total phosphorus concentrations and losses were observed at the Garvey-Glenn EOF site following manure application in late October (Figure 16). Three years later manure was applied to the field again, but during the drier period in August when no runoff was generated. Adjusting the timing of the application at this site measurably reduced losses. A similar occurrence was observed at the Huronview Site when a fall application of phosphorus (P) fertilizer was followed by heavy rains and resulted in significantly higher TP losses. These high runoff events can happen any time of the year but have been more common during the non-growing season during the ONFARM trials. The Fairview site has been added because it offers an opportunity to evaluate manure application practices.
